Ferrymead Tram Tracts

The Newsletter of the Tramway Historical Society Incorporated

April 2022

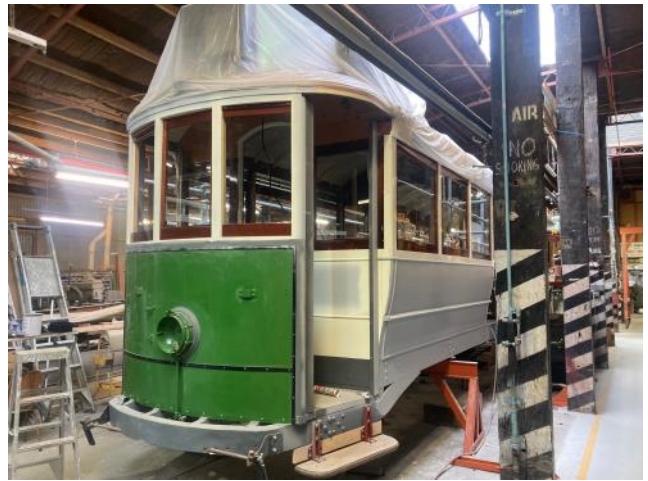
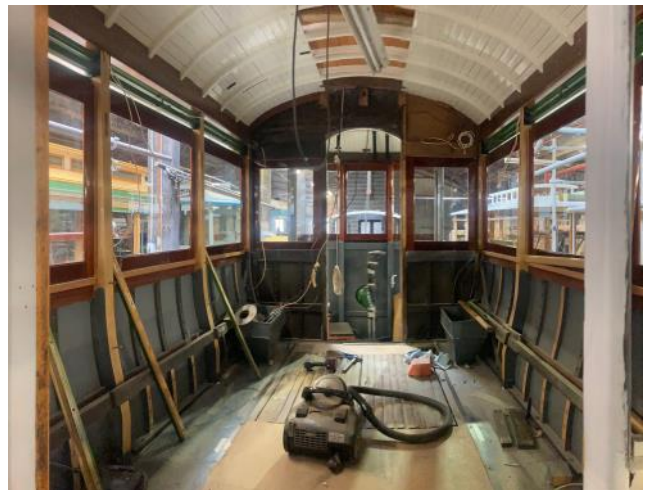
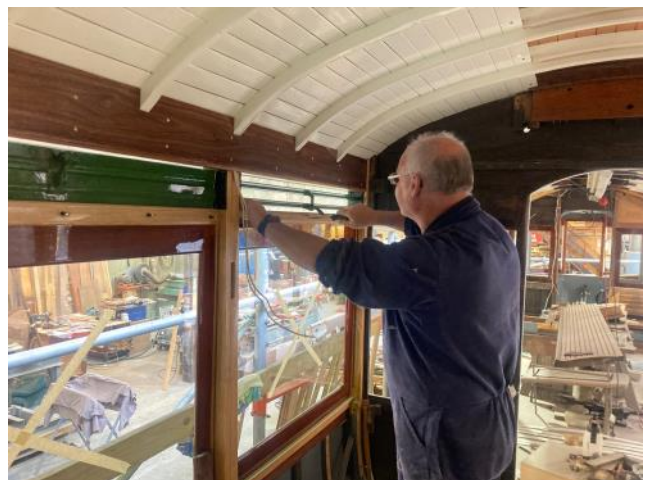
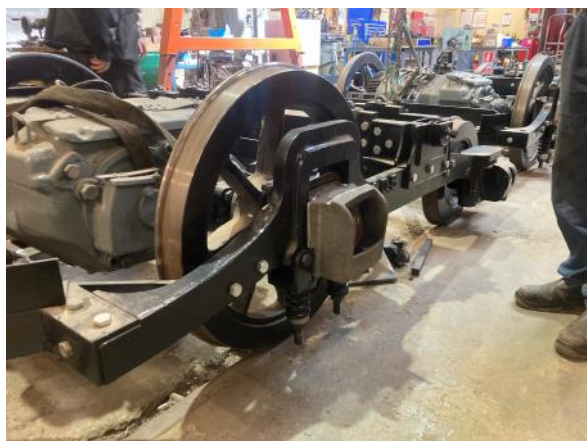
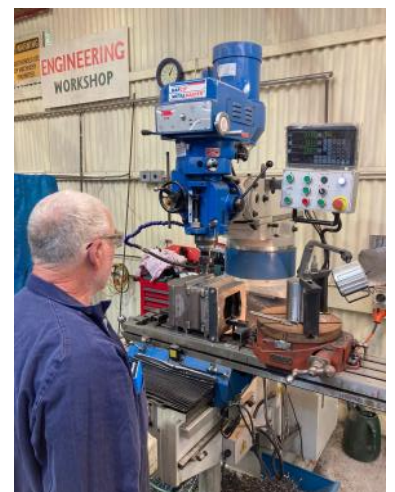
Top: A end cab with all the windows in and the white paint now sprayed on

Upper Mid: the saloon area taking shape nicely.

Lower Mid: Heritage Craftsman Brian Fairbrass installing a window trim.

Bottom right: Engineer Bob Williams machining an axle box.

Bottom Mid: A ceiling panel frame being made ready to install.

Bottom Left: Now fitted to stay is an axlebox within the truck frame, Looking great!

24 is continuing to make good progress, the staff have been busy completing the many components for the saloon area and 'A' end cab.

Bob Williams has been busy doing components for the 14D5 trucks, The axleboxes are largely complete and they are waiting for the new axlebox lids to be manufactured by an outside company, they will arrive soon hopefully.

Additionally Bob has been manufacturing Brake components to allow the brake equipment to be installed. The Main brake pull levers have been away for welding and have come back and look great, just the holes to be drilled and hardened bushes to be fitted.

Brian Fairbrass and Mike Hobbs have been fitting the various components in the saloon area, the Cab windows are now in to stay and look great, also the saloon side windows are in to stay, the beads that hold these in are new and have been made by Graeme R and look really great, these components are varnished and the wood grain really is beautiful.

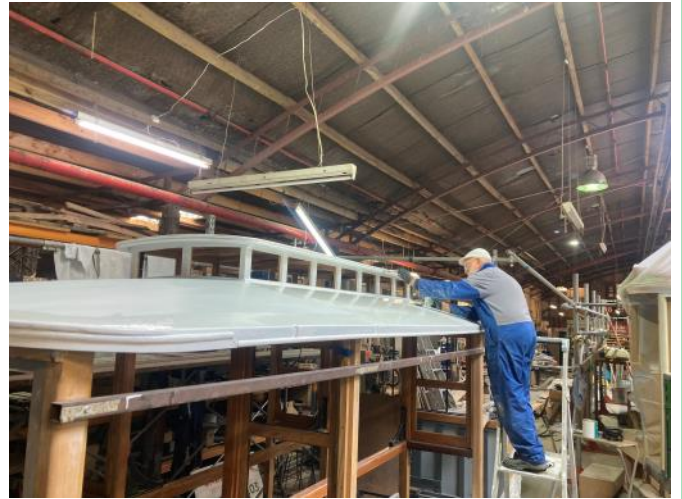
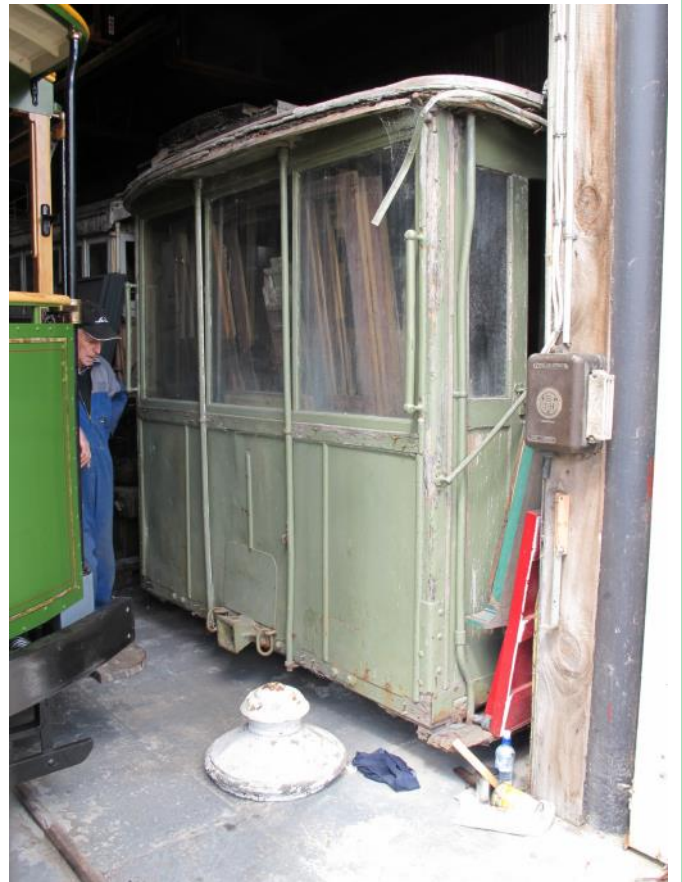
Top Photo: Don McAra putting another coat of paint on the roof of 103, it is certainly looking great!

Middle Photo: The late Trevor Craib, a great mover and shaker of the Cable car movement, looking at the Down pipes as described by Don in the article.

Before one last coat of paint, the sixth, goes on the roof of grip car 103, we have to complete the roof's rain-draining arrangements. These must have been added some time after the car went into service. We can imagine complaints loud and clear from platform standees on the leading platform of trailers like 111 as it followed the towing grip car as it went up High Street's steep slopes in Dunedin. When both tram and trailer took a sudden upwards incline, the rain water would have sloshed from the grip car's roof onto unsuspecting heads.

Arrangements involved fixing wooden barriers at the B (city facing) end of the roof, and drilling one hole at each of the roof corners which led to down pipes there. No down pipes were needed at the uphill A end. In the centre of the B end roof, six more holes in a flat metal plate directed water into a metal reservoir fitted under the roof's soffit. From there two more downpipes ran on either side of the centre window down towards the road.

All four downpipes and the original reservoir have been saved and will be reused. I am currently working on a brass replacement for the six-holed metal plate and the short copper funnels to be soldered to it.

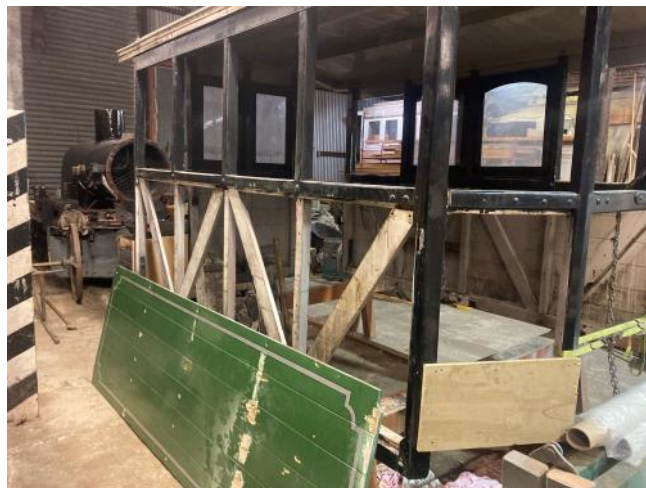
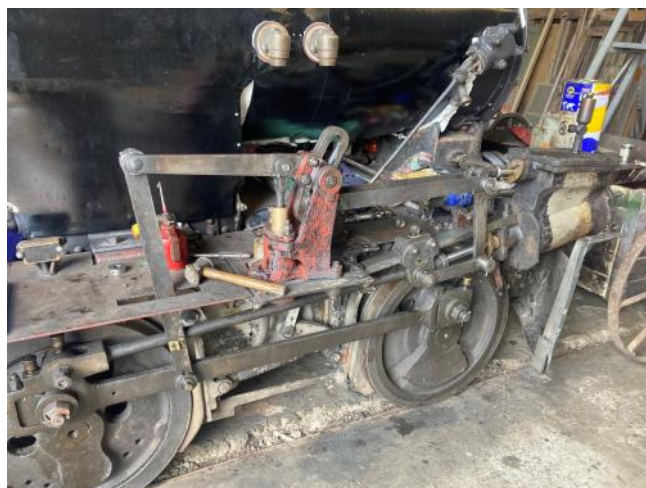
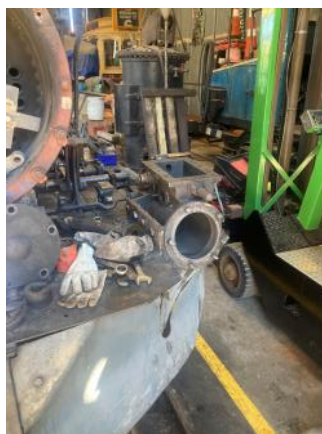
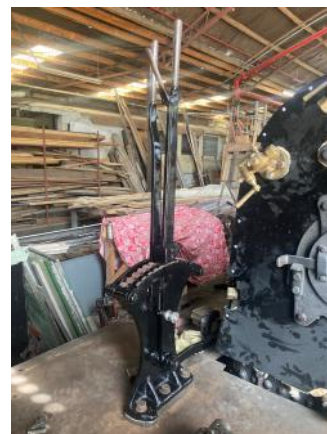
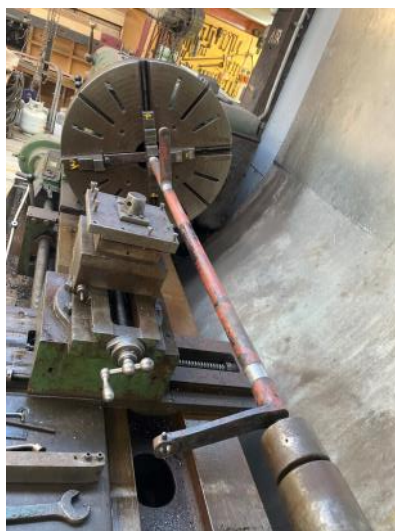
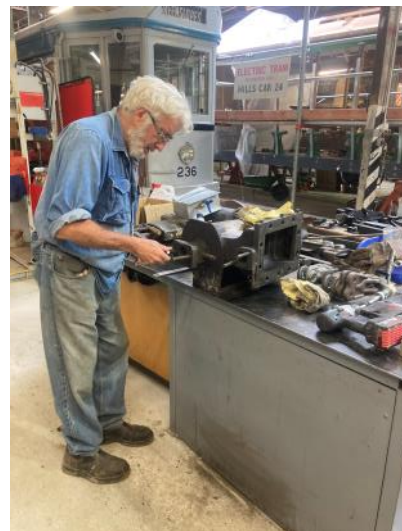
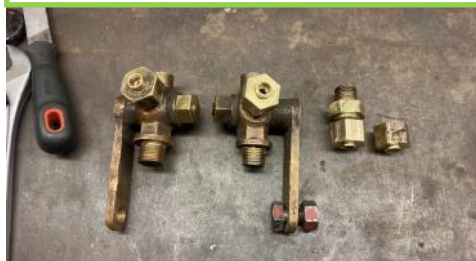
Top : body work with the side off ready for paint preparation.

Mid Top: The RH Valve gear all assembled and ready for setting up.

Mid Left: The LH cylinder bolted on.

Mid Right: The overhauled Reversing stand.

Bottom Right: Steve lea attending to the LH cylinder threads

Bottom Middle: The weighshaft in the lathe

Bottom Right: The repaired drain cock valves.

In the last month the left side steam cylinder has had the bore honed by Steve Lea, on the same day we refitted the cylinder with new bolts that fit much better than the old ones, Bob Williams of the HTT has made these for us and did a great job.

Additionally the Right side valve gear has been refitted, this required a number of new pins and bushes as they had significant wear, and the valve guide bush was also worn so a new one was turned up on the lathe.

Stephen Taylor has made some progress with the bodywork repairing old screw holes and a bit of degreasing of the angle braces. Next will be sanding and some painting for that side.

Another task that has happened this month is the welding up of the bearing surfaces on the weigh shaft, (the purpose of the weighshaft is to move the valve gear on both sides at the same time into forwards or reverse), and machining them round again on the big Churchill lathe. This lathe is normally used to turn the tram wheels so it was interesting to use it for some thing other than that.

The cylinder drain cock valves also were in need of attention, I took these home and worked on them as they are in the model engineering field! . Two of the original pipe fitting nuts were missing, they had been replaced with modern flare type fittings, so I turned up two new ones then got Ian Fanshawe (our former boiler inspector) to screw cut the 14TPI threads on them, Many thanks Ian for doing this for us.

The reversing stand was in need of some attention also, it has had new bushes fitted and new pins as the existing ones were worn out and the stand received a fresh coat of paint. With this done it should be easier to drive with less clearance in these components. More next month.

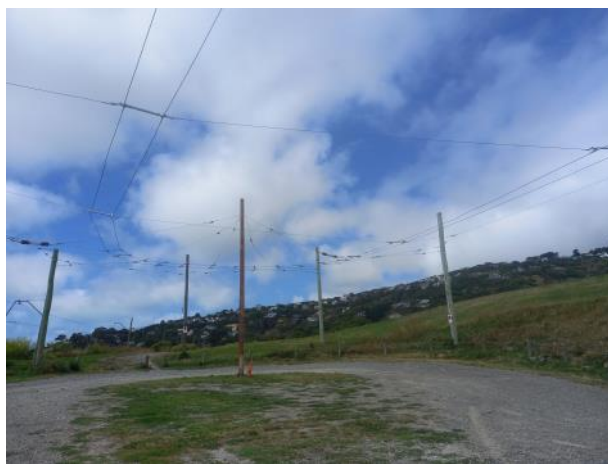
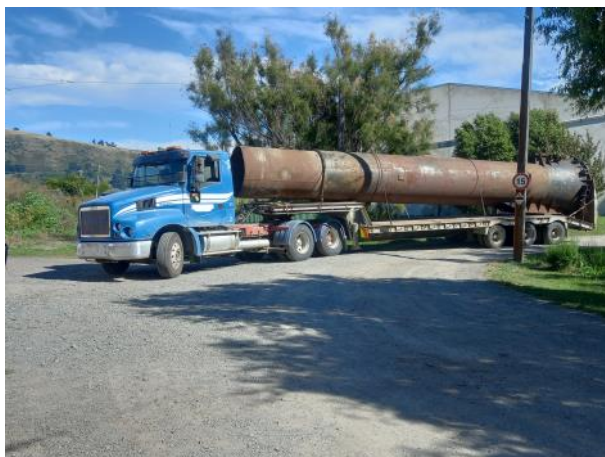
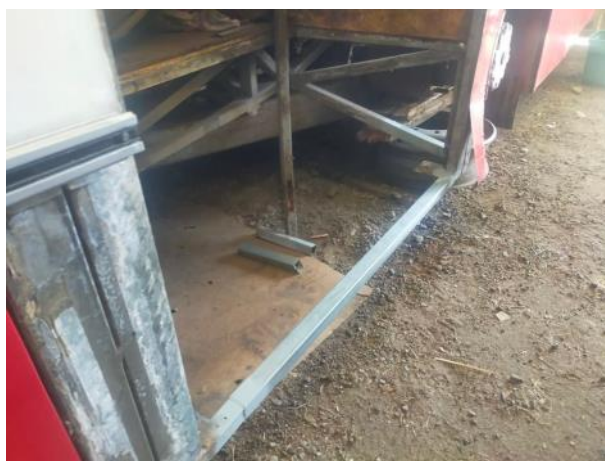
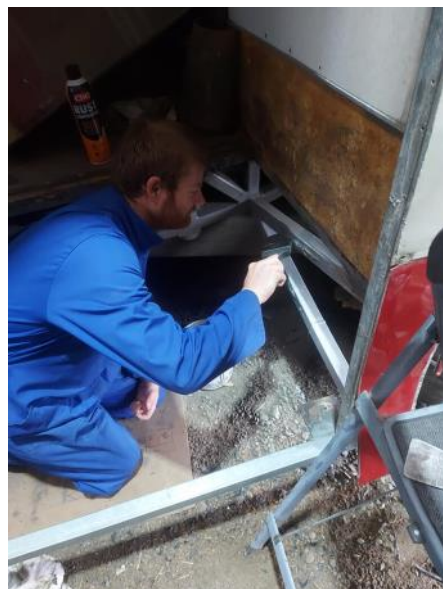
Top photo: Showing the Turning circle at the far end of the system with the new overhead sweeps visible on the Left.

Upper Mid: The Chimney starting its journey to the West coast to become a Drainage culvert!

Lower Mid: Bus 612 with the back steps removed and ready to receive its new steelwork.

*Bottom : Dylan Roberts at work painting the step steelwork.
(Photos: P.Murphy, D.Roberts, J.Day and A. Roi)*

The overhead crew are making good progress with renewing the turning circle support structure. As has been stated already the overhead has been in the skies for a number of years and was showing its age and we are altering the style of construction. 5 sweeps are to be installed and replace the wood break style of construction. All the mounting plates are installed and by the time you read this at least some of the sweeps should be installed. The attach pic shows some of the mounting plates in position. The only unpublished pic of this work I could find.

Work continues on the steps. Since the last report the front door steps have been removed and both sets of steps have had new sections of steelwork welded in. All the structure around the rear steps has been painted with protective zinc paint. The front step area will receive the same treatment and then the fibreglass step units and doors will be refitted.

Sitting in the way of the major tidy up we are gradually undertaking was the ex CTB boiler house chimney. The committee agreed for it to be shifted and our scrap merchants recently came in and cut it into 2 sections ready to be transported off site. Instead of being sold for melting down and returning with Toyota on a badge, it was sold to Birchfield Energy where it will be used as drainage culverts on their haul road. The proceeds from the sale of the chimney will be put into continuing cleaning up the site around the trolleybus area.

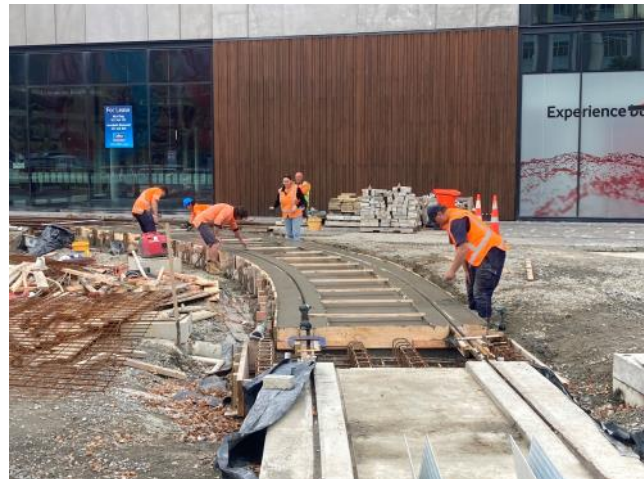
The Contractors recently have been putting in the final round of reinforcing rods under the point work and sorting out the area to allow the final 4 rails to be installed.

On Thursday 17th March saw the 4 rails arrive from Track industries and were being levered into place by the surface-men, Next up these were Thermit welded over the following weekend.

Wednesday 23rd saw the concrete put in up to the top of the rail, now the rails are all welded in place and the final earth loop testing has taken place at the gap area.

Tuesday 29th, another round of concrete was poured around the track break loop testing point, this leaves one last concrete pour to take place for the track construction around the points and the siding road in the same week. Hopefully after that we can do some test runs.

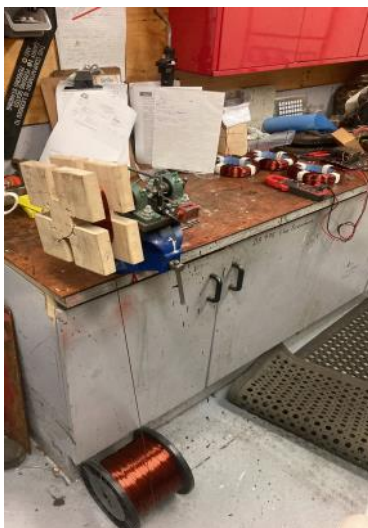
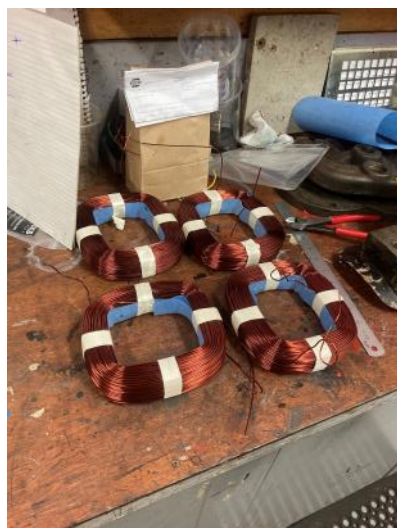
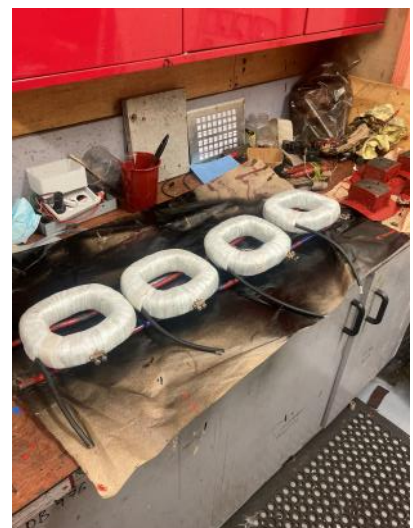
A few months back we had some fields fail on one of the many CP27 air compressors, these were 100 year old original ones with cotton insulated windings. With no serviceable spares or info to get new ones made, I did some research over the lockdown last year and put info together to make some inhouse.

The bottom photos show the field coils being wound their 361 turns of 1.5mm winding wire. Next up wrapping many layers of insulation in its various forms. They are nearly ready for installation and should see it running for the next 100 years. We cleaned up the original terminals and soldered them on. More next month.

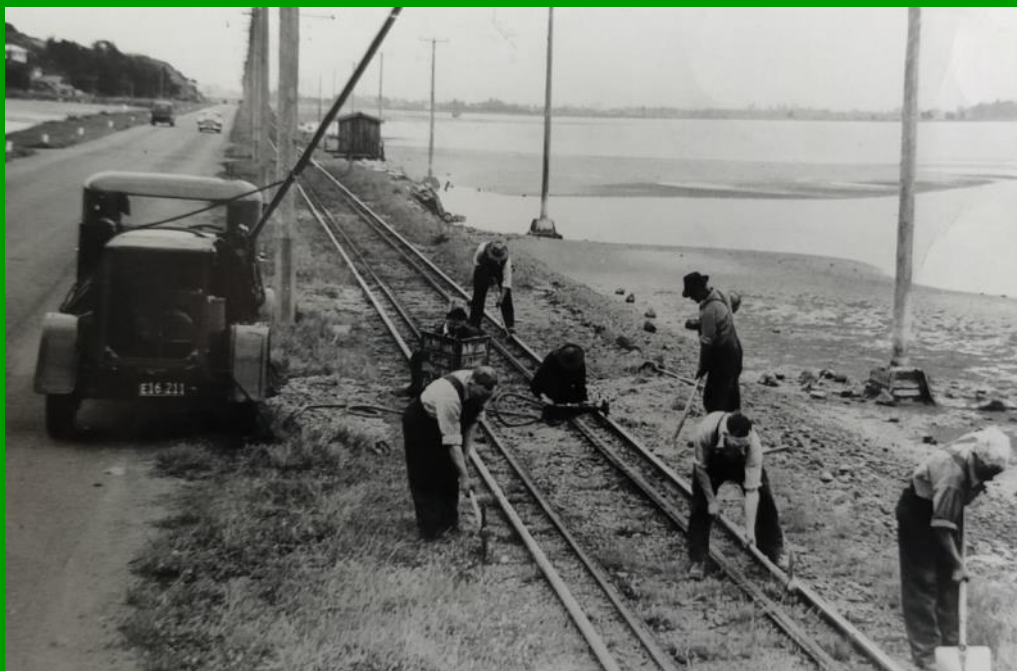
The editor spotted this fantastic picture on a page called ' Remembering Christchurch' . It is of a track gang working on the McCormacks bay Causeway in the 1940s

They look to be doing some track repairs, the guy behind the shield looks to be doing Arc welding and the worker with the stone grinder flattening it off, it would be interesting to see the Generator/welder set that is taking its power from the 600V overhead power, the Society has a similar setup on the 5W Beast works tram. Amazing stuff.
