FERRYMEAD

Tram Tracts

The Newsletter of the Tramway Historical Society

Issue 59—September-October 2021

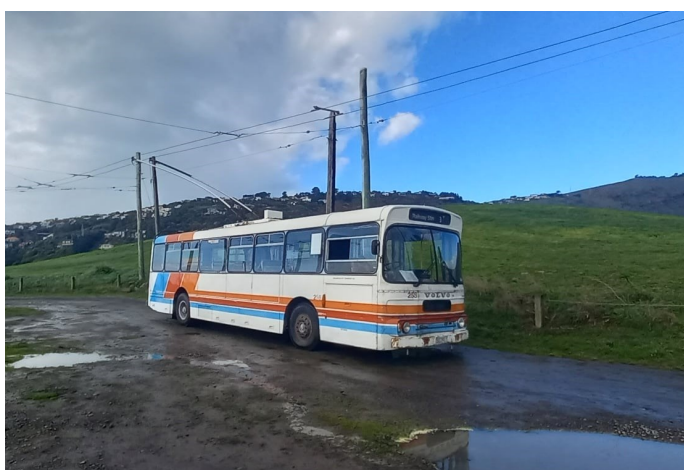
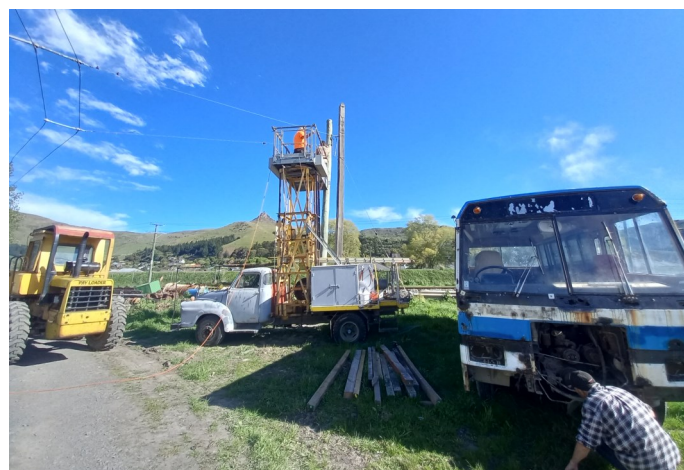
ABOVE LEFT: 258 Alive! Wellington 258 lays over at the Truscotts terminus of the trolleybus loop after its first post-repair test run, 15/8/21.

ABOVE RIGHT: Work continues to switch existing overhead fittings from old to new poles around the Trolleybus Shed as work continues on ex-Ashburton Bus Company 38 to prepare its motor for extraction and fitment to the Bedford tower wagon.

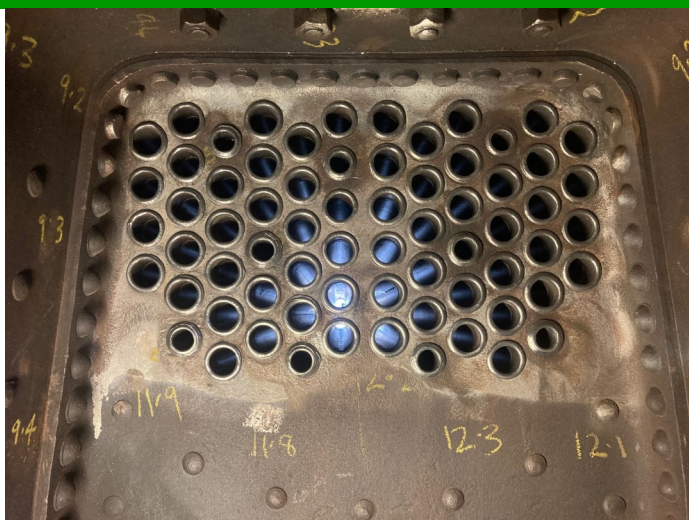
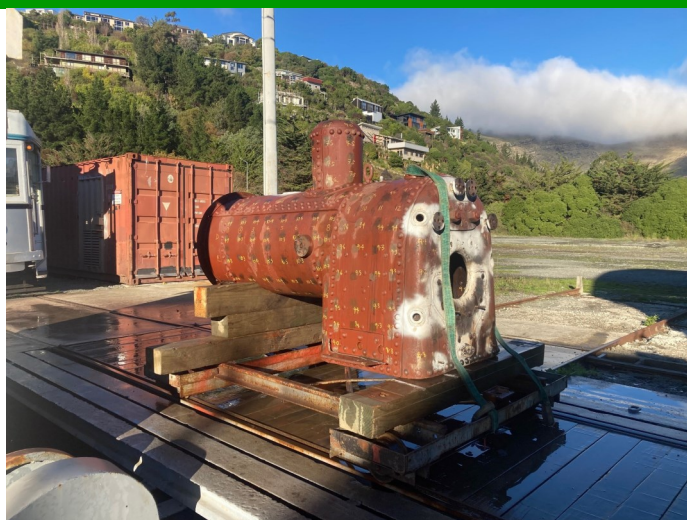
THREE PHOTOS: *From top left:*

- *The firebox tubeplate with all tubes now beaded over*
- *The boiler on the traverser after having ten years' accumulated grinding and welding dust washed out*
- *The tram engine chassis and cab separated in Tram Barn 1 in preparation for the boiler swap.*

Then on Friday 24th September, we were fortunate to have Gerard Greenlees of the Diesel Traction Group come along with his Scammel Hiab truck to lift the old boiler off and fit the replacement boiler on the frame. Many thanks to Gerard for doing this for us free of charge.

The boiler inspector is returning in mid-November to do the live steam test; once this step is passed, we can refit the body and fit the new tongue and groove side boards.

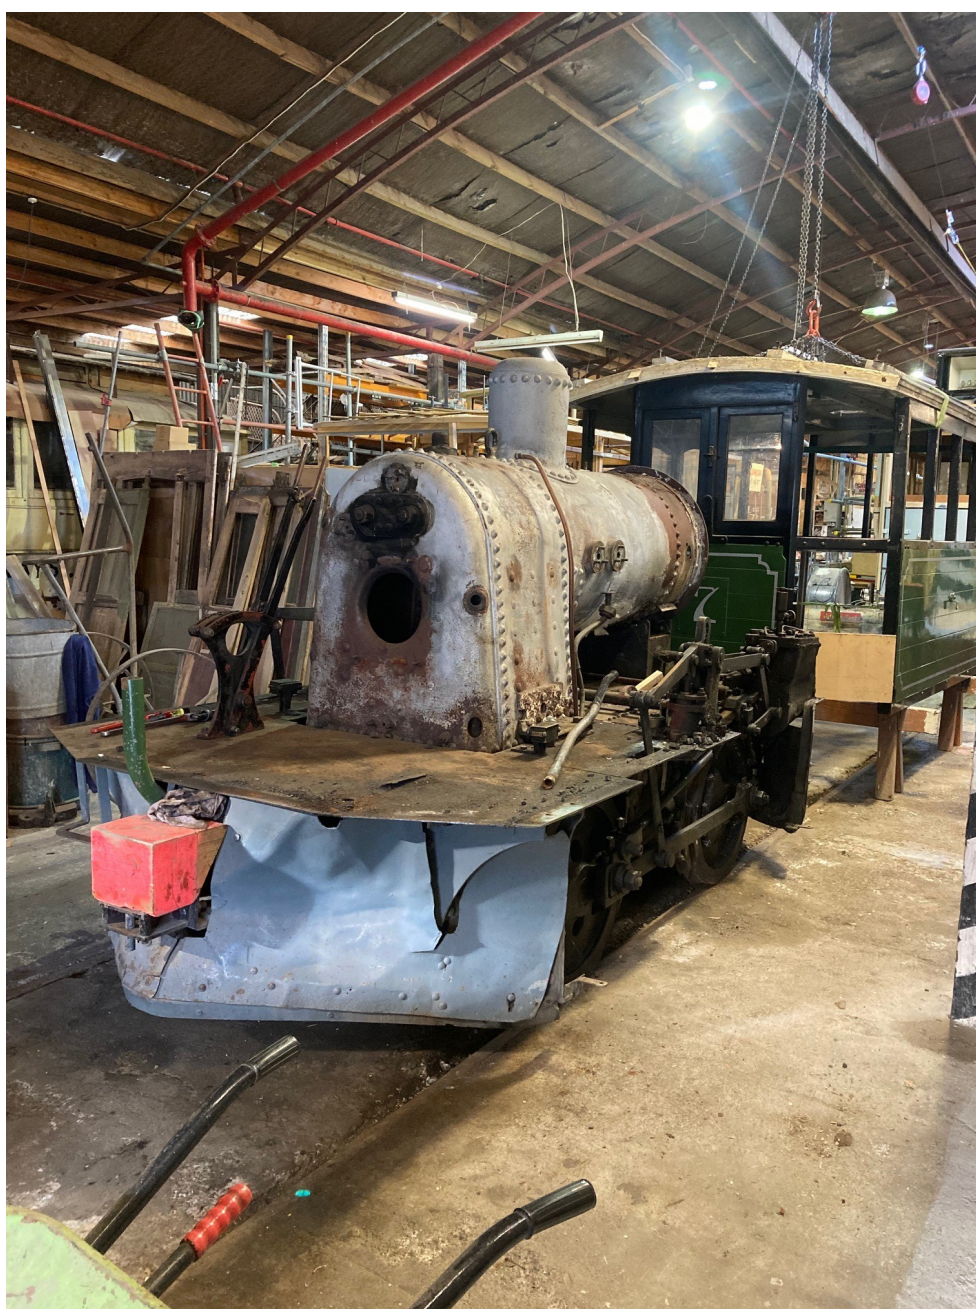
FRONT COVER: *The big swap takes place! Gerard Greenlees' Hiab crane lifts the new boiler into place on the chassis, 24/9/21. Since this photo was taken, Alex and Steve Lea have re-drilled the firebox mounting plates to adapt those on the new boiler to the Kitson's chassis.*

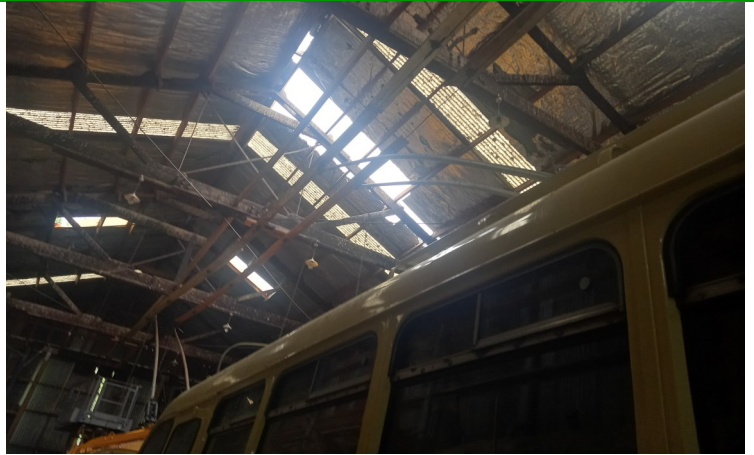
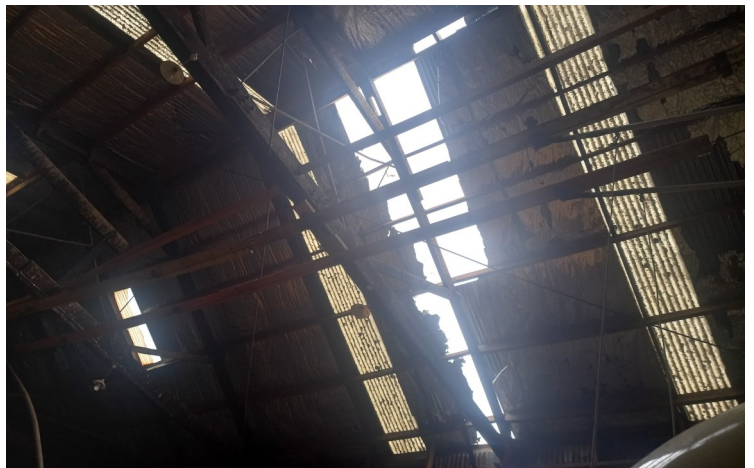
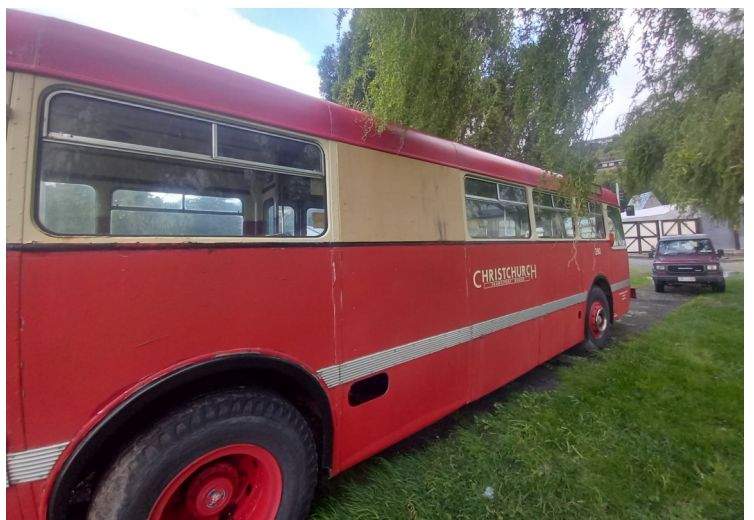
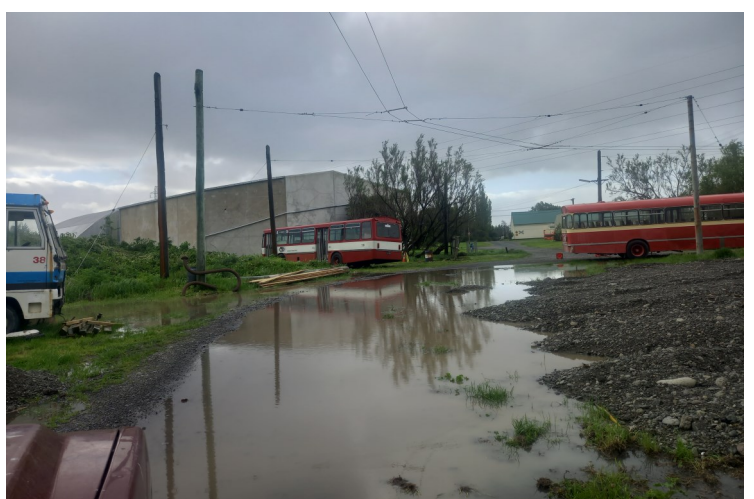
ABOVE RIGHT TOP: *At least three sheets of roofing iron were torn off the Trolleybus Shed during the winds; the damage is more clearly visible from nearly directly below (**middle top**)*

LEFT: *Mk IV 290 showing the repairs carried out by Graeme Richardson to keep it weather and visitor proof.*

BELOW RIGHT: *The high winds were accompanied by heavy rain, which flooded part of the ring road around the Trolleybus Shed. Thankfully none of the buses shown were damaged or at risk of damage, although it has been noted that rainwater did penetrate through the bottom of Bristol Hess 538's door seals.*

Further investigations around Ferrymead soon proved that the Trolleybus Shed roof was not the our only victim of the gale-force winds that day. Tram Barn 1 had lost some new long-run steel sheeting which had been blown off the lean-to section and been bent, possibly beyond repair. Tram Barn 2 had suffered instances of roofing lift, and a number of windows had been smashed.

The fourth and final Society asset to be damaged was AEC Mk IV 290, which had been parked beneath the willow trees beside Tram Barn 3. A branch had broken off and landed on the bus with enough force to smash one of the offside windows. Graeme Richardson quickly obtained some plywood and has now covered over the damaged window to keep the weather, and other unwelcome guests, out.

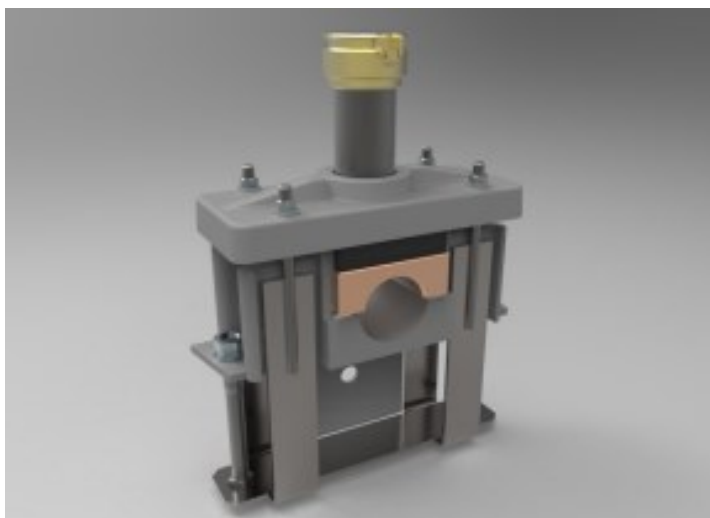
An initial design was developed from old photographs and the 3D models of the parts were sent to a pattern-maker. These were used to produce basic patterns for the parts that were to be cast. For the parts that were cast from SG iron, the top casting and the part that is the casting that the rubber shock pad is sandwiched between, these being simple, have worked out well. It is a different story for the bronze bearing casting. This part, as we are making it, is a good example of not understanding this component as well as we should have at the start. The bearing castings as cast will work, and do the task they have been designed for, but require way too much machining to be completed. This machining has been performed by me, with no cost for my time, and some by the workshop staff engineer Bob.

Even though these parts are being finished at this time, I think revisiting the design and construction of the wheel sets and bearing assemblies will be a useful exercise. We will just look at a way to improve the actual cast bearing brasses, mainly the patterns and casting method. After looking through an old foundry textbook, from 1902, I also came across common practices when making cast wheels. From the old photographs of the original wheels, I suspect these were made from chilled cast iron rather than the cast steel the replacements have been made from. The curved spokes these originals have is a requirement when this type of casting is produced in cast iron. The curved spokes help reduce the stress concentration that can build up as the casting cools. Cast iron is a brittle material, steel is a more ductile material, so the curved spokes are not required. The image, here (*shown overleaf*), is a rendered image generated from the 3D cad model.

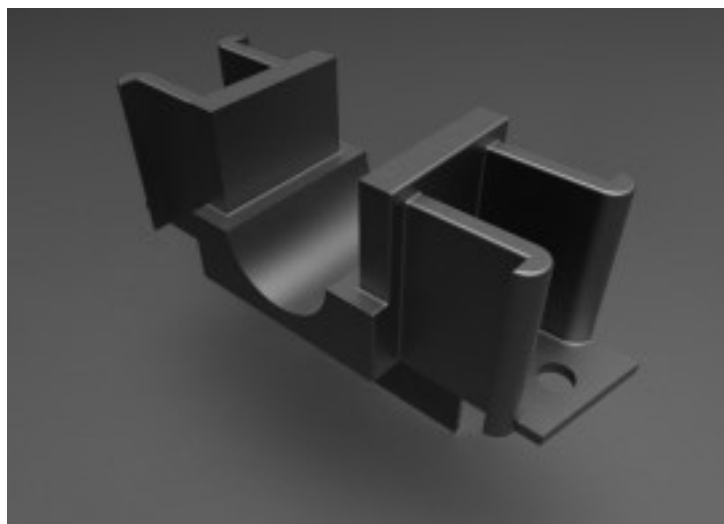
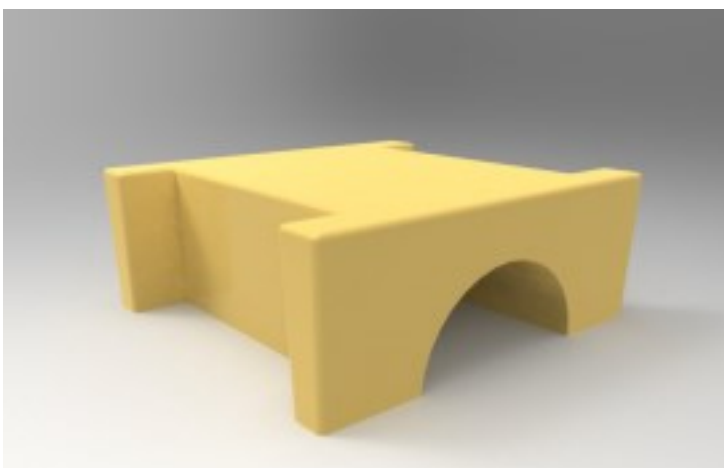
The original wooden pattern

Although this model is a good representation of the existing castings, fixed to the chassis frame, the most important detail, looking at the existing castings, is that there are no machined faces where the bearing shells are located, and move up and down. These are, as cast, not machined faces. This detail probably was not taken notice of as much as it should have been. As these are just cast faces the original bearing was a loose fit. How loose, is anyone's guess. The first pattern made from my 3D CAD model was quite a loose fit. When the parts were cast this pattern was not used. The tram barn foreman made another pattern which had a generous allowance for machining, and this was used for the castings. The original was quite a loose fit, though if packing shims had been used on assembly, this might have proved to be a good way to adjust the wheel alignment. The original pattern possibly may have been too loose a fit, but there is definitely too much machining on the pattern used. Also due to the taper designed into the original pattern to allow for the wood pattern to be withdrawn from the sand mould, the locating faces in the bearing casting needed to be quite tapered. This taper possibly would have been a problem.

Now the actual specifications for the required pattern are starting to sort themselves out. Firstly, for reasons considering the nature of the mating faces, and secondly, for the cost of the labour input required, we want to eliminate most of this machining. For good functioning in service the only faces that need to be machined are the thrust faces each end of the bearing, and the radial face that runs on the axle. As the faces that fit against the existing bottom casting are running against are, as-cast, and not machined faces, these are only required to be as-cast faces as well. It is preferable that these be square and parallel, that is, have no taper. Going back to the 1970's and 1980's when I was learning my trade and working on an NZCE

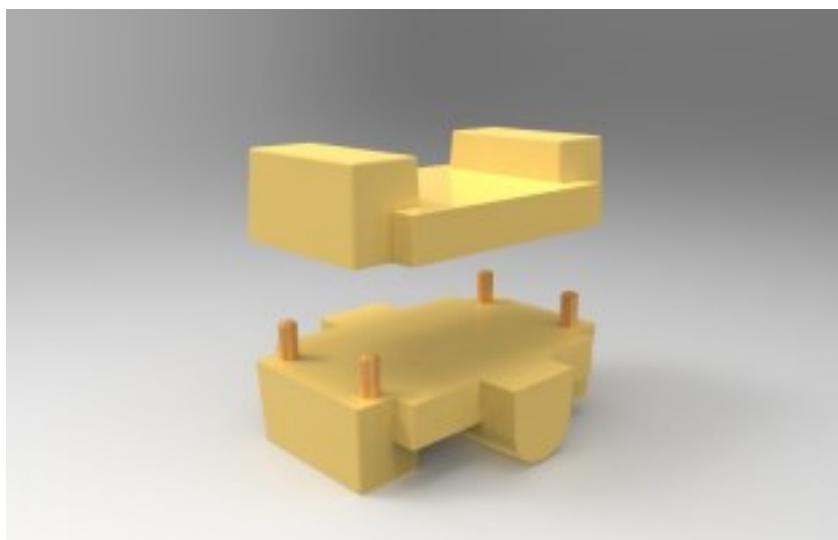
two of the cores will be identical. Here (*bottom of previous page*) is a basic model of a possible casting setup. The casting, in this image, is the yellow block. The recesses, in each side locate the type 2 cores.

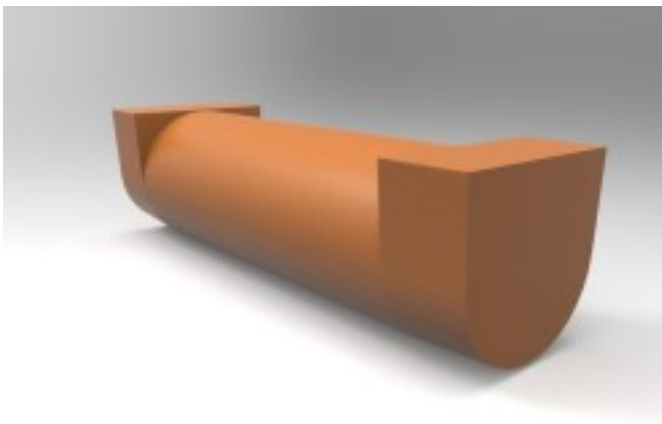
Type 1 core—one required

The type 1 core in the bottom casting forms the rough bore that will be machined to fit where the bearing fits the axle bearing surface. Back in the 1980's, before our modern computer-based technology became the tool it is today, getting castings and their patterns made was a different process. A paper drawing would be produced, and a skilled pattern-maker would become involved. A pattern-maker was a well-qualified and

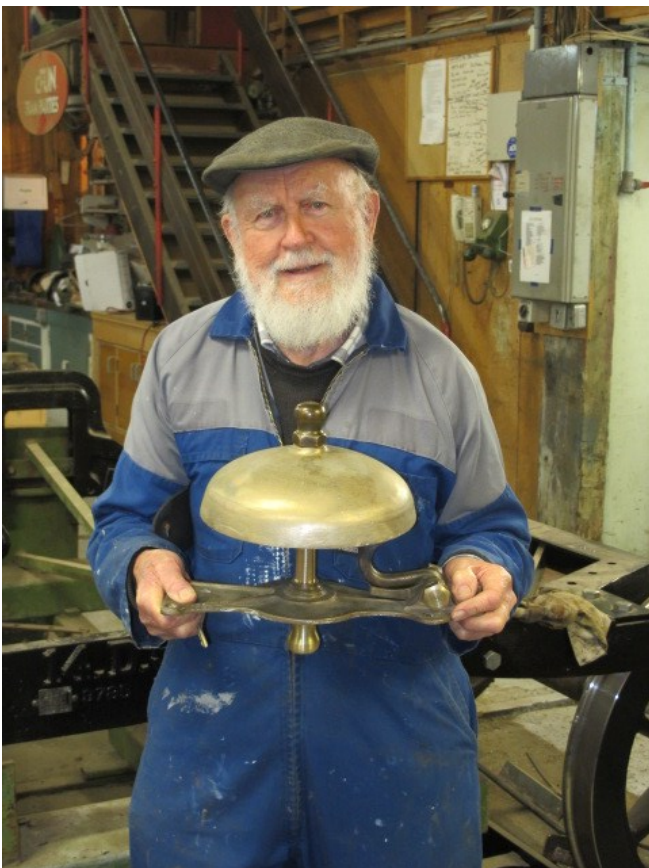
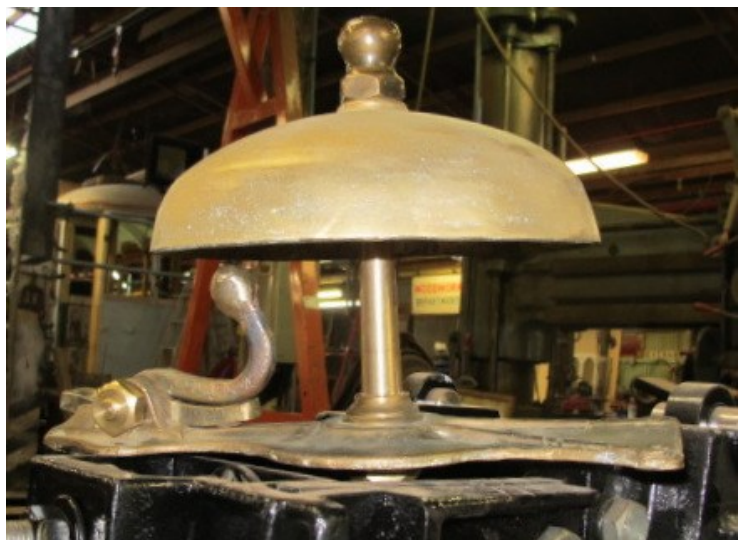
TWO PHOTOS: Back in the present day and slightly more palatable, Don and his team have recently restored this bell for Mornington grip tram 103. In later years these bells with their distinctive tones were painted all over, ostensibly to prevent verdigris.
