Tram Tracts

The Journal of the Tramway Historical Society

Issue 15—June 2017

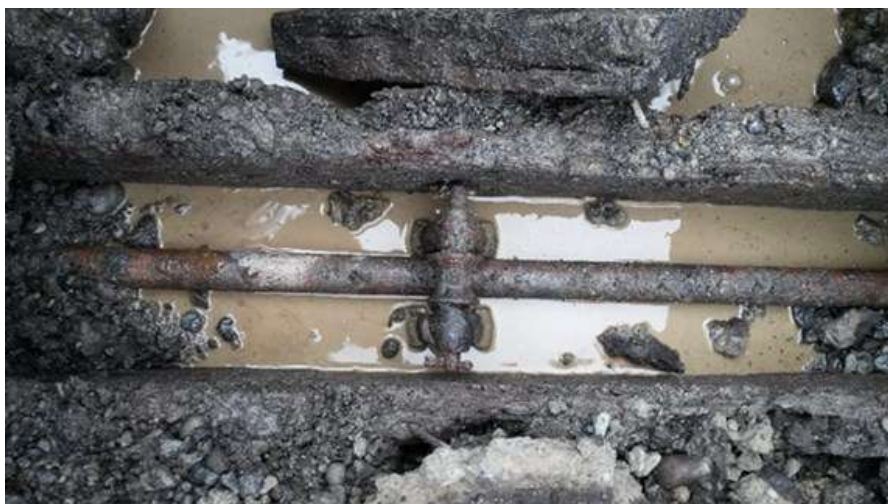
LEFT: Part of the catch point rodding in situ, Riccarton Road. The suggestion of these remnants being related to cable cars comes from the wooden trench that the rodding ran through, which is still clearly visible in this photo and had been unearthed for some distance when Dave visited the site.

Dave was invited to go on site and investigate, and following consultation with several people, including Graham Stewart and Rachel Tucker from the Ferrymead Railway and after some of the relics were extracted, we were able to positively identify what they were. The unidentified items in question turned out to be part of the old point operating equipment for the tram catch points on Riccarton Road where the tram line crossed over the Main North Railway Line.

The tram line in Riccarton Road was installed around 1906 and closed in 1953. The tracks were removed after the line closed, and until this discovery it had been thought that no other tramway remnants still existed. However it seems that when the crossing keeper's box was removed, all equipment generally outside the rail boundary was just abandoned and the CTB knowingly or otherwise had just removed the rails and sleepers.

There were five tram/train crossings in Christchurch, the others being Fendalton Rd, Lincoln Rd, Antigua Street and Colombo Street and while similar catch points and signalling had been installed there too, no remnants have ever been found. The rodding and rollers were standard railway equipment for the time, and examples still in use can be seen at the Ferrymead Railway which also displays the former Sockburn crossing keepers hut and signal box, of very similar design to that formerly at Riccarton Road. A section of the rodding and rollers and the surrounding wooden edging retrieved from Riccarton Road has been donated to the THS and it is anticipated that these relics will form part of a future display at Ferrymead featuring elements of the old Christchurch tramways infrastructure.

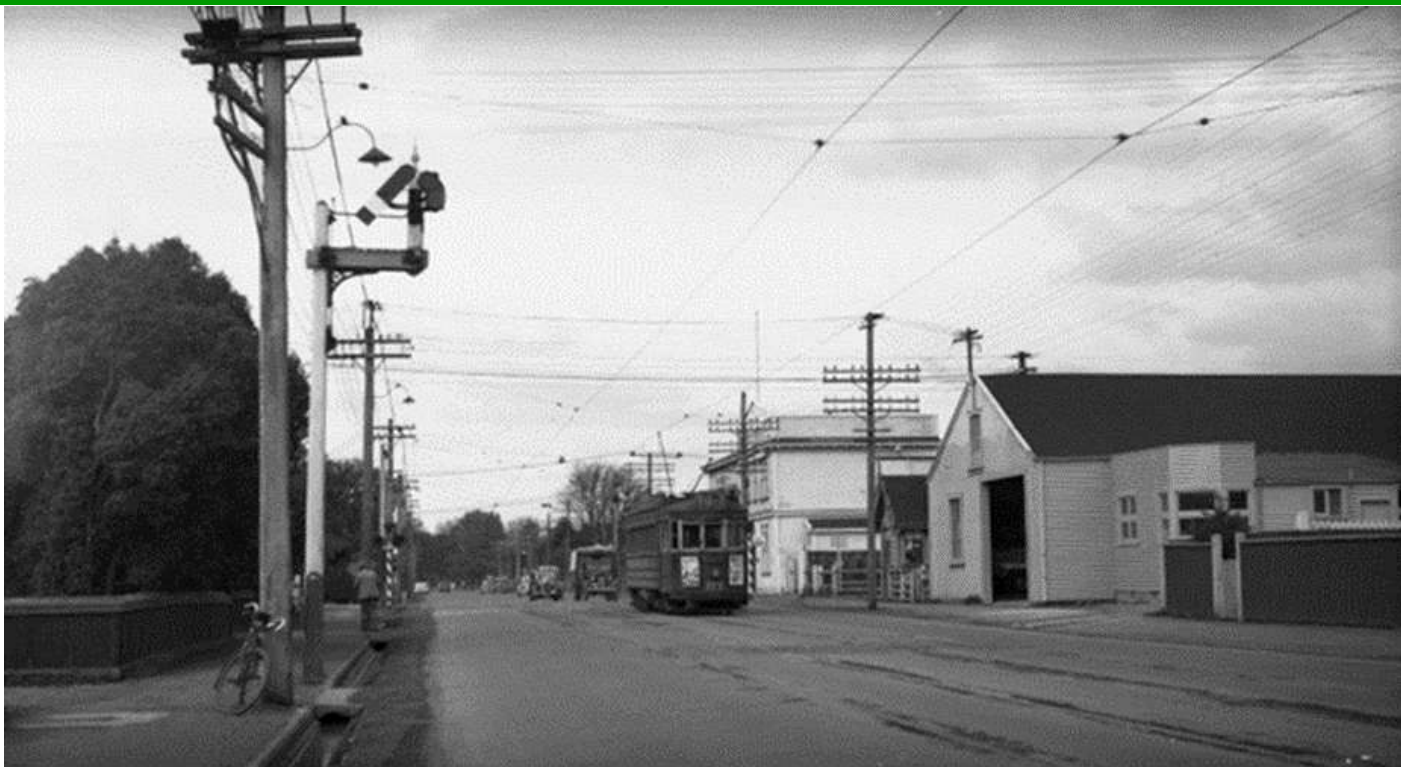
ABOVE: A 'Brill' tram crosses the Main North Line at Riccarton Road heading westbound. In the foreground is a standard McKenzie & Holland railway semaphore signal, controlled from the crossing keeper's cabin to the right of the 'Brill', and used to indicate whether train or tram had right of way. The signal was interlocked with the tramway catch points which were meant to derail trams if they attempted to cross against the signal.

The photo at bottom right also helped solve part of the mystery – some thought the trench might also have contained the cabling to the semaphore signals but the white post adjacent to the then recently installed flashing lights gives the answer – the cabling was overhead - see the large pulley wheel on the post, sending the wire down to the signal (out of picture.) It would have been undergrounded from the signal box on the opposite side of the road - see the finials above the tram. The Graham Stewart photo at top right also shows this post.

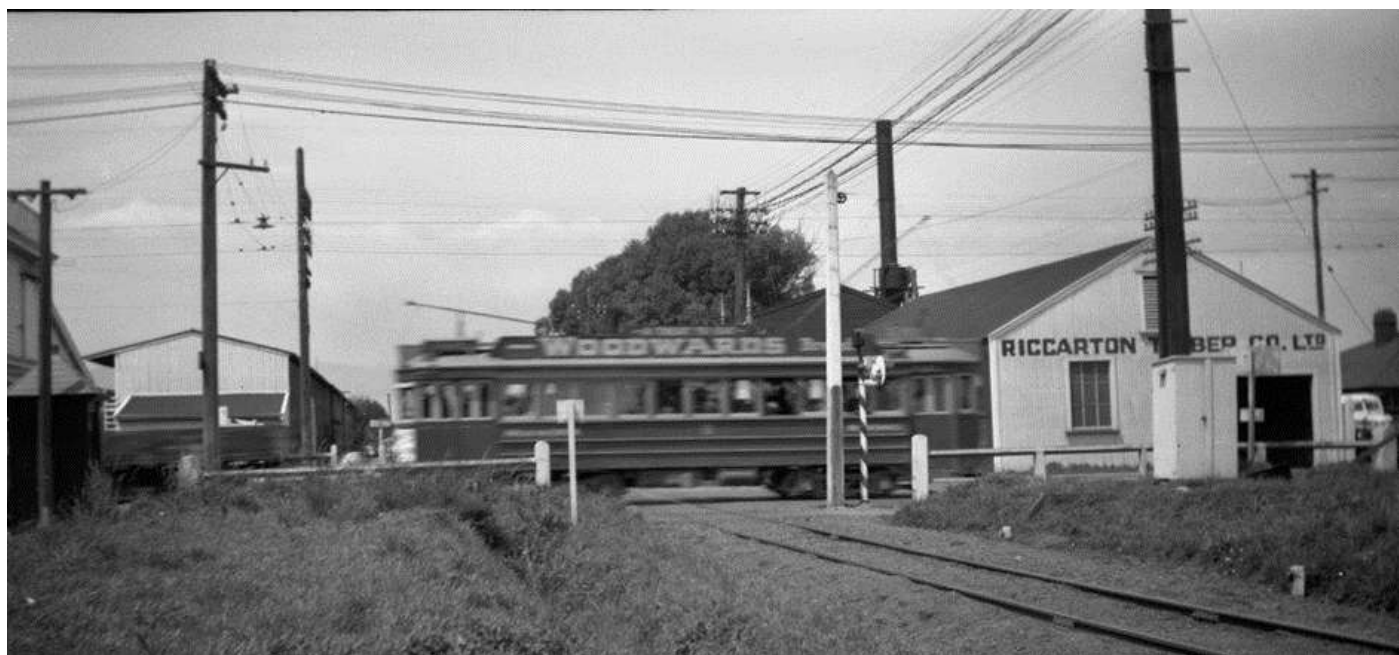
BELOW: A Cathedral Square-bound 'Brill' hurries across the Main North Line. The white mast behind the recently installed crossing lights carried the wires for the tramway signal on the western side of the crossing, as shown in Graham's photo above. The two finials above the tram roof are those on the roof of the crossing keeper's cabin.

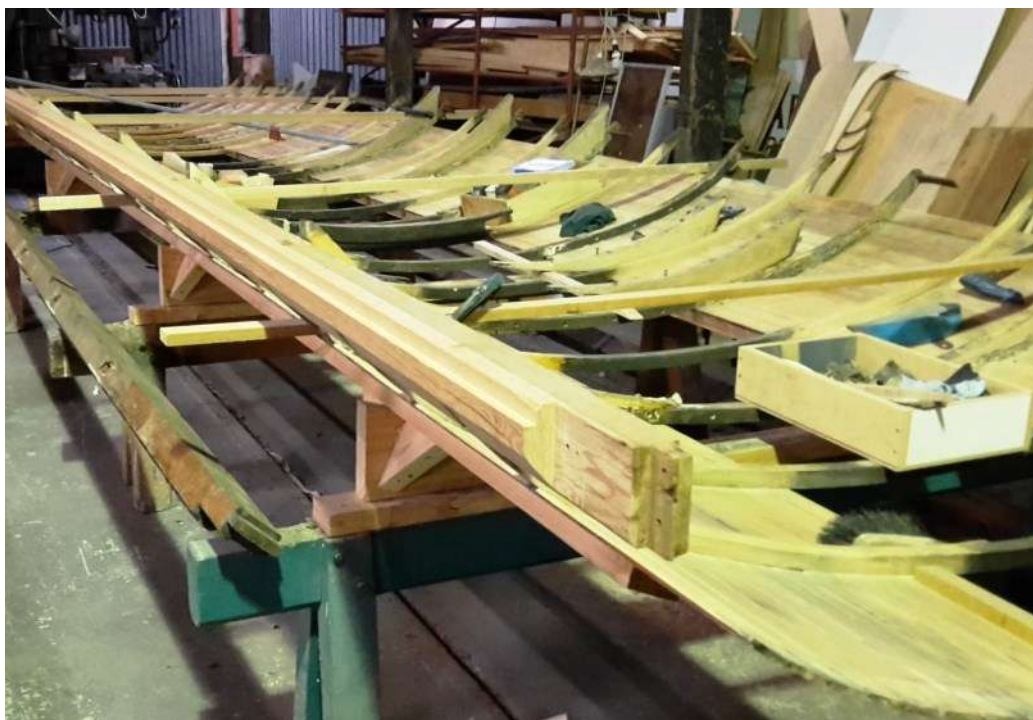
With a decision now made on the final appearance of Hills car 24, work is now well underway on completing the roof. One of the top plates has been temporarily fitted in this photo; the other will be so treated once the roof bows have been repaired when needed. Then the roof interior and top plates need to be painted, the roof bow reinforcing strips need to be sanded, primed and painted for refitting. Then everything can be finally assembled and the finished roof installed on 24 to complete the body.

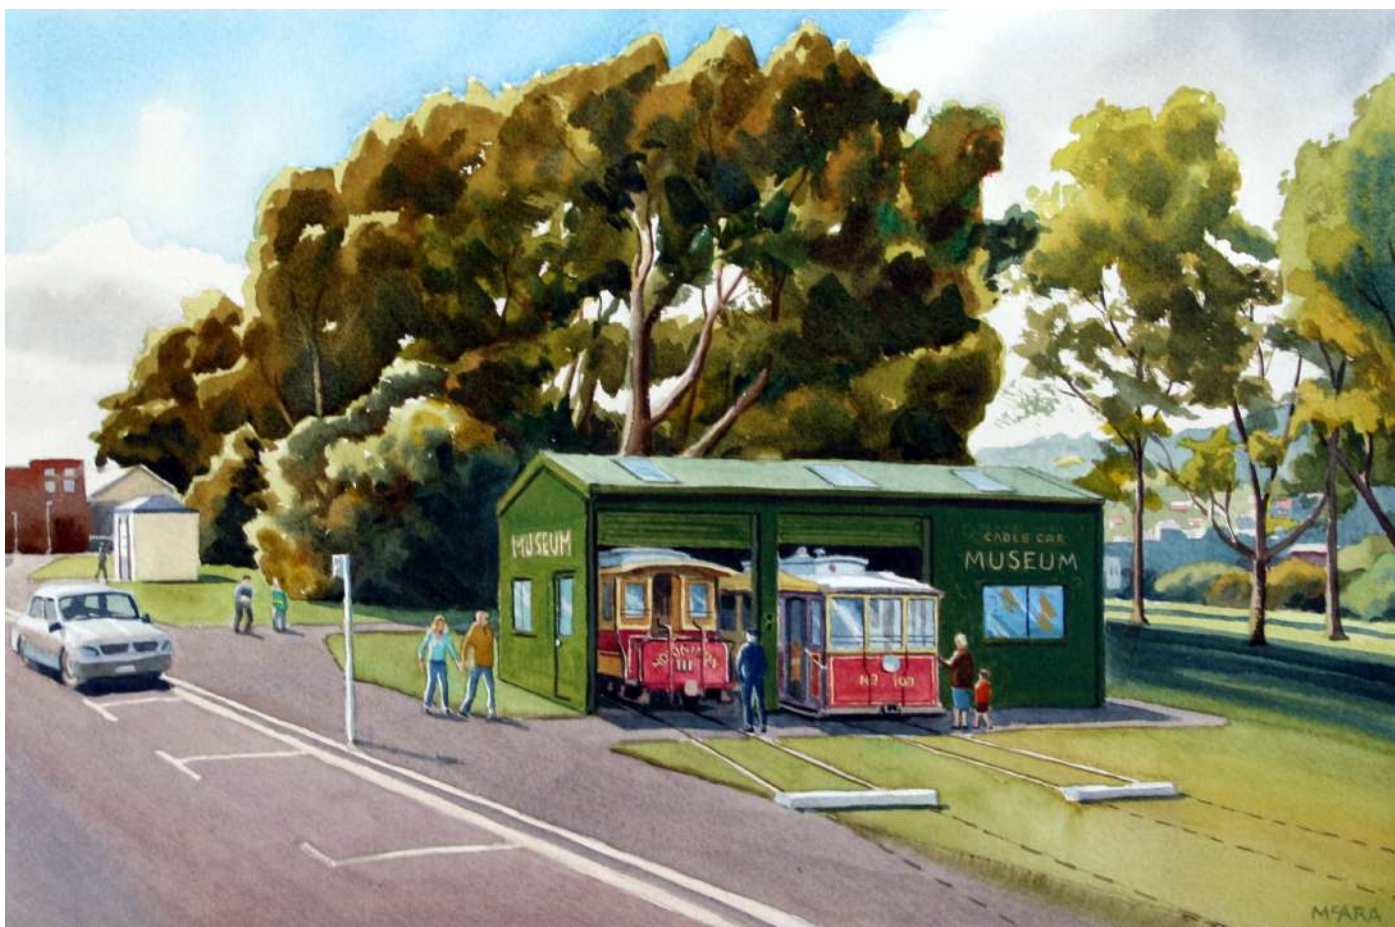
ABOVE: *The vision for Stage One of the Dunedin Light Rail Trust's Dunedin cable car project. The display building will initially house three cable cars—two grip trams and a trailer—with two short lengths of track which will allow the Trust to display the cars outside. No cable conduit will be needed at this stage; the dotted line demarks where additional track will be installed as part of later stages. Original Painting: Don McAra.*

*The Dunedin Light Rail Trust's proposal for a cable car museum in the Mornington Domain is now advanced. **Don McAra** provided the following blurb to accompany his painting (above) of Mornington trailer 111 and grip tram 103 in the proposed display building:*

The aim of this small building is to be as a money raising display for a larger Stage 2 Museum. On show will be three of our vehicles; two restored Mornington cars—grip tram 103 and trailer 111—and the body of Roslyn 97, which will not be mobile and be displayed in 'as received' condition behind the right hand window. Roslyn 95 will be sent before Mornington 103 in its stead until restoration of that car has been completed, and be viewed as a typical Dunedin Grip Car.

The Stage 1 museum building is here shown sitting on the foot print of a rather ugly former toilet block and redundant changing rooms. If the DCC would remove that it would be a great help for the Dunedin Light Rail and Cable Car trust's plans. No slot or conduit is needed at this stage.

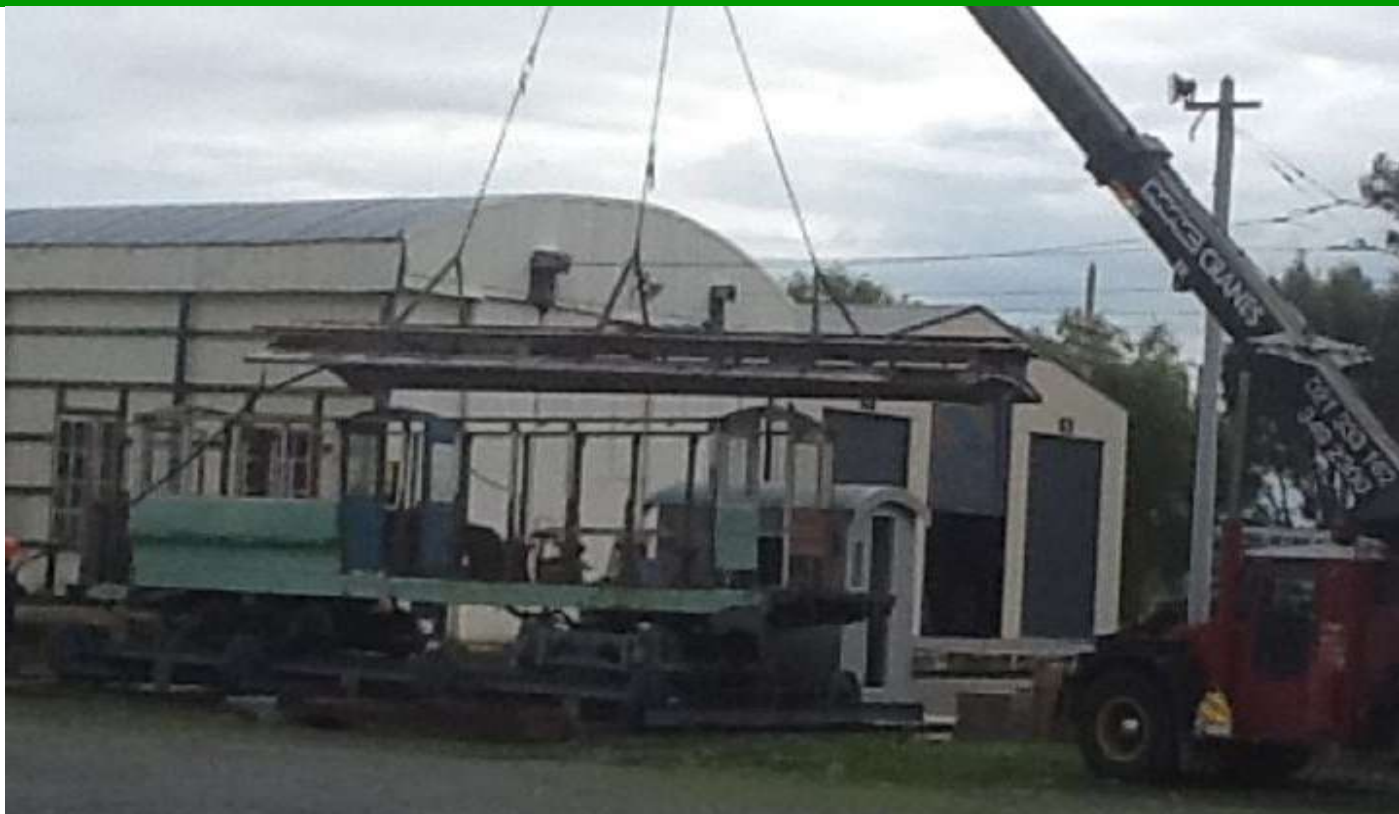
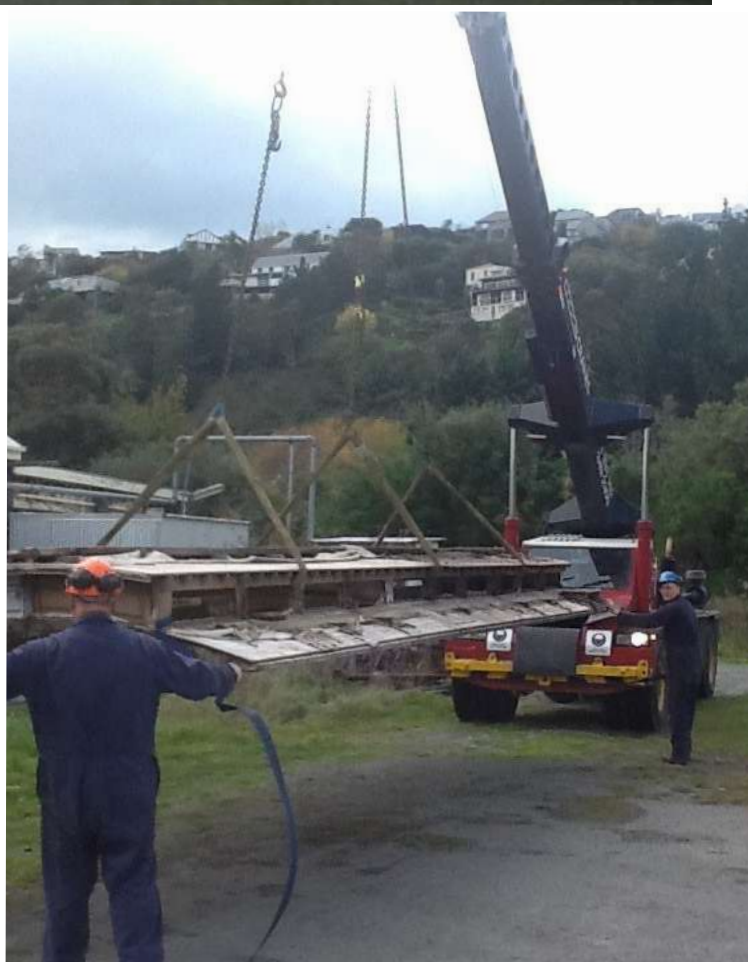
THIS PAGE: Off with the roof! Parked on the extended traverser, (top) 'Yank' 12 has just had its roof lifted off by a hired crane truck. The job of 'flying' the roof to the storage container fell to Graeme Richardson and Brian Fairbrass (right), in conjunction with the crane

truck's driver. The roof is now stored high up in the container on a set of rollers set in beams attached to the container wall. Photos: Gary Webber

The body of 'Yank' 12 has now been completely disassembled down to floor level, including removing the original floorboards which had been damaged, with parts affected by borer. The removal of the roof section took place on 12 May and since then the bulkheads and sides have also been removed and put in storage with the other salvaged components in the container provided by the Sydney Tramway Museum. The double thickness steel side plates of the chassis were also removed and this caused the chassis to immediately become more flexible and to sag at the ends. It was then discovered that the outer plate on each side was a later addition shown by some redundant bolt holes in the inner plates. Following some photographic research, it was concluded that the outer plates had been added by the CTB, probably in 1908. Photographs taken before 1908 show that the 'Yank' trams had begun to sag at both ends of the chassis. Photos taken after that time show the the outer, wider plates attached, and a straight chassis, therefore curing the problem.

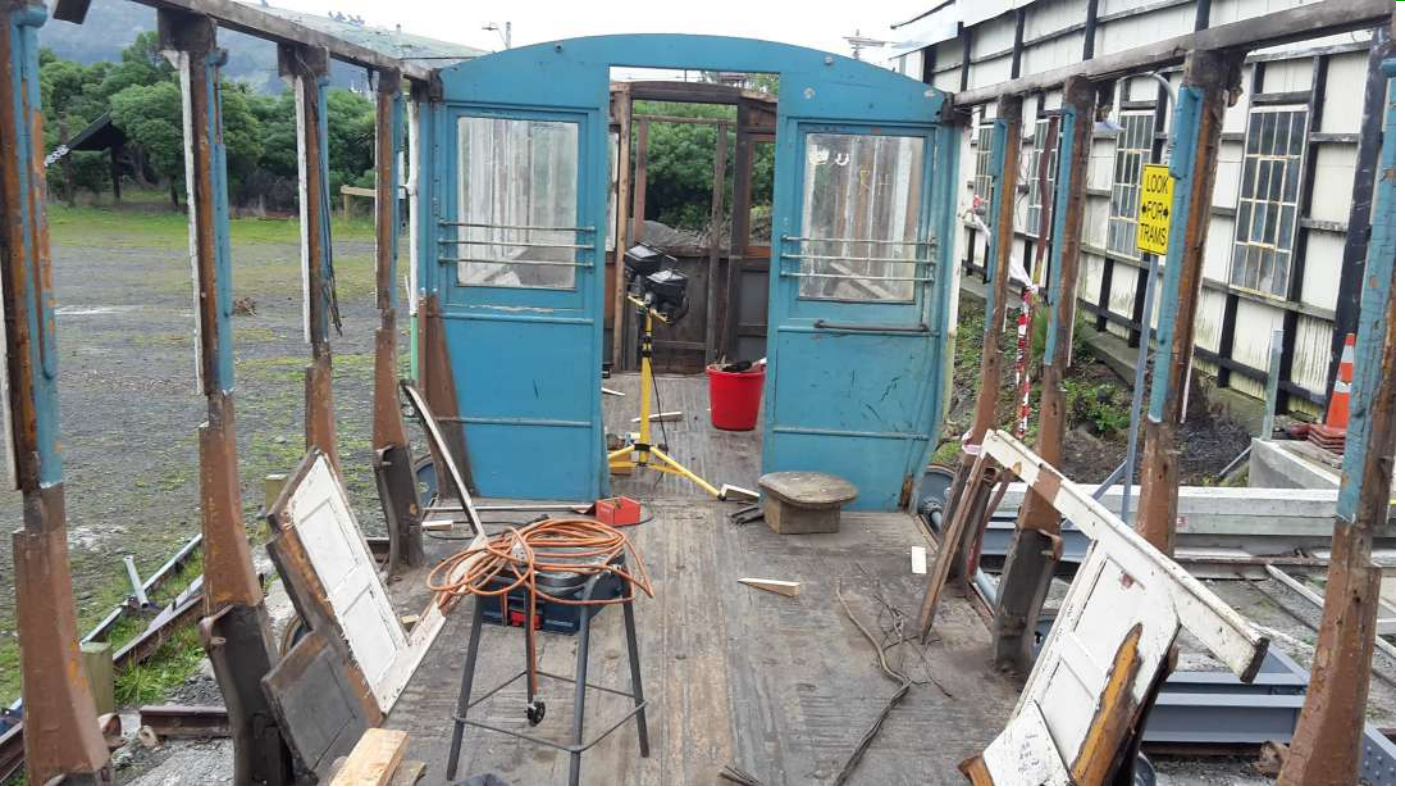
ABOVE: A different perspective on the ‘Yank’ with the roof off. The last time any tram of this type would have looked like this would have been back in 1904-05 when they were being reassembled in Christchurch after being made at the Stephenson factory in New York.
Photo: Dave Hinman.

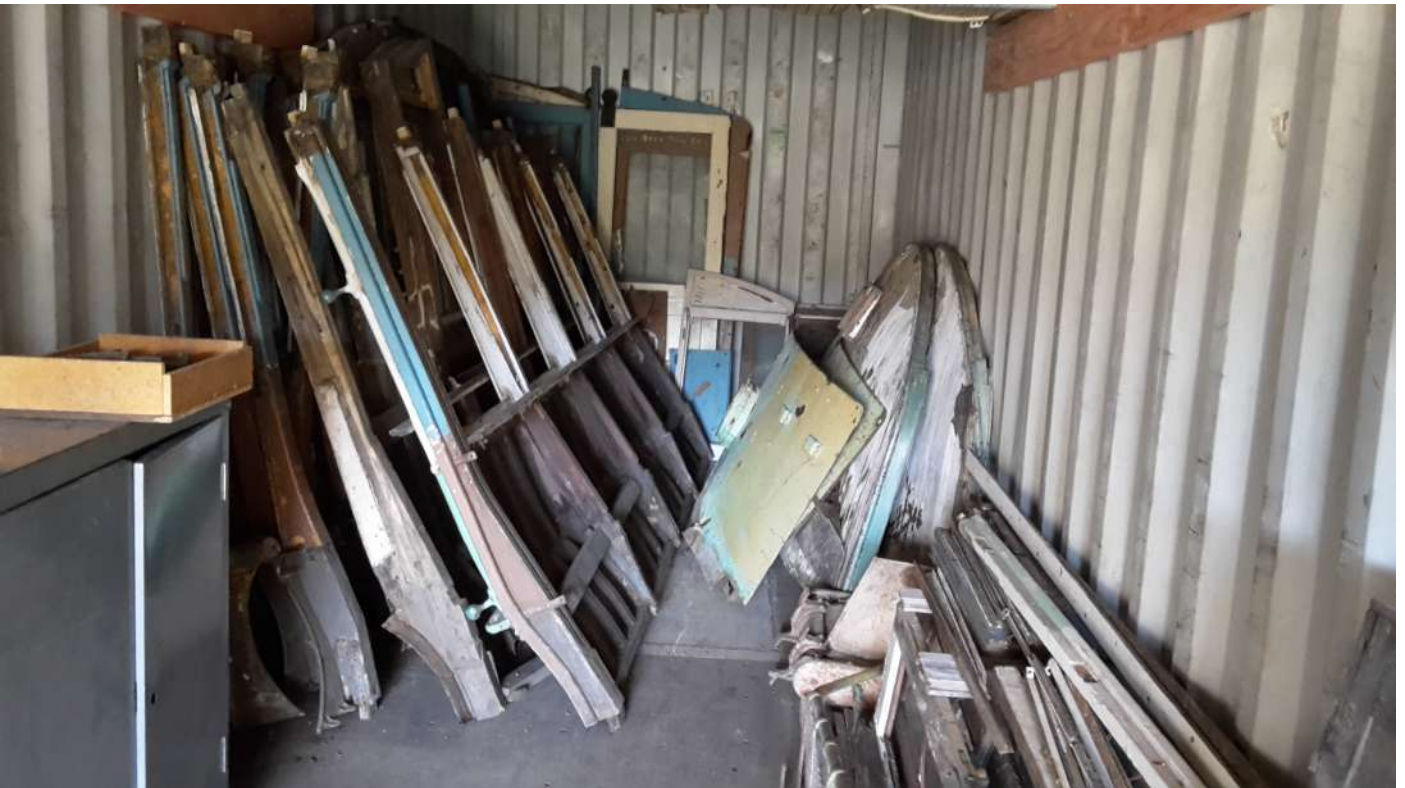
ABOVE: Looking very full, this is the majority of ‘Yank’ 12—now disassembled down to a ‘twelve inch to the foot’ kitset and tucked away in the STM’s container. The roof hangs above the assorted components below—the main parts still missing are the twin steel side chassis plates (photos of which will appear next issue), the low end platform (separated from the chassis) and the chassis itself, at this stage still being worked on.

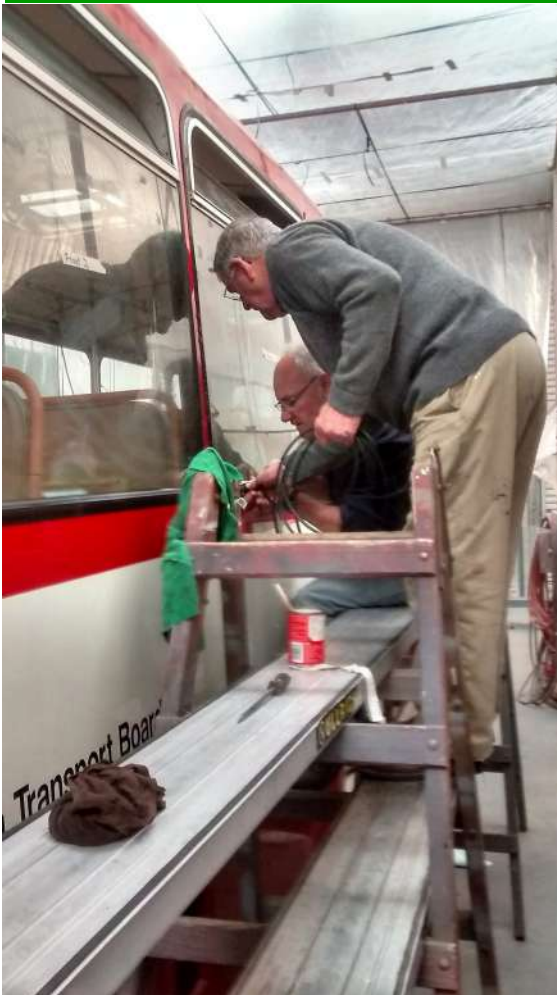
The Bus Team have recently completed installation of new window rubbers on ex-CTB bus 538. John Atkinson (on ladder) and Brian Fairbrass work to install yet another rubber during this important finishing task. Photo: Graeme Belworthy.

The normal repairs and maintenance goes on as usual keeping the vehicles and infrastructure operating. This is what allows the Society to present the public image we are known for, the trams and buses. One of the jobs underway at the moment is refitting the windows in bus 538 with new window rubbers. This has turned out to be a little more difficult than anticipated but we are making progress albeit slowly.

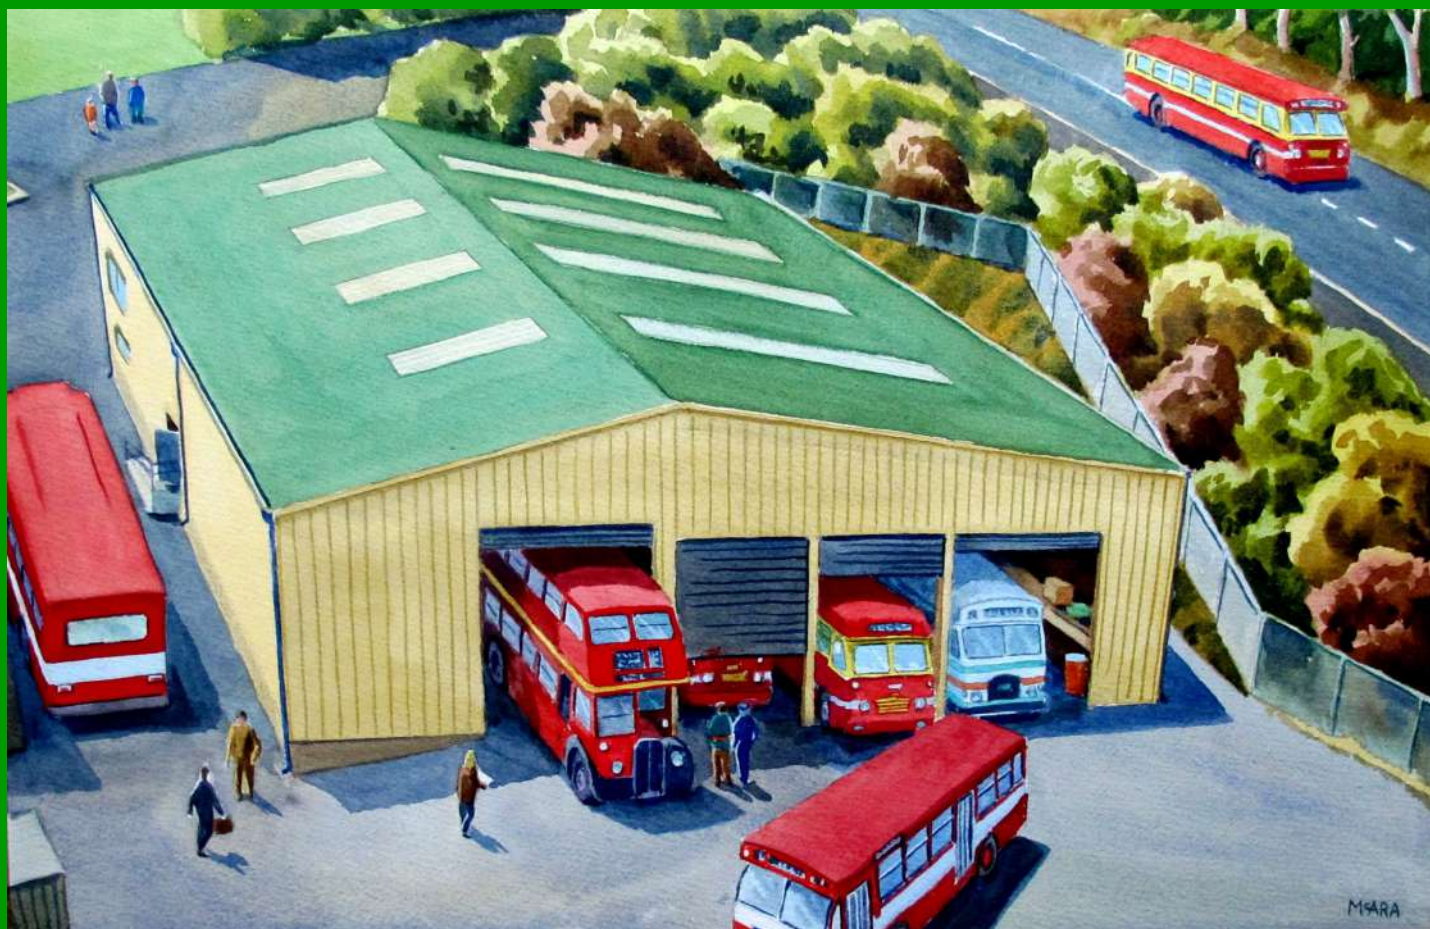
ABOVE: Coming Soon! With planning on the Diesel Bus Shed now well underway, Don McARA has painted this vision of what the real building will look like once finished. The Totalspan shed will be capable of housing our full diesel—and petrol—bus fleet including our ex-London Transport RT-class double-decker. With our buses and their spare parts under cover, out of the weather and away from the vandals (!).
